City of Windcrest

Leak Detection Pilot

Leak Report Windcrest TX 2014

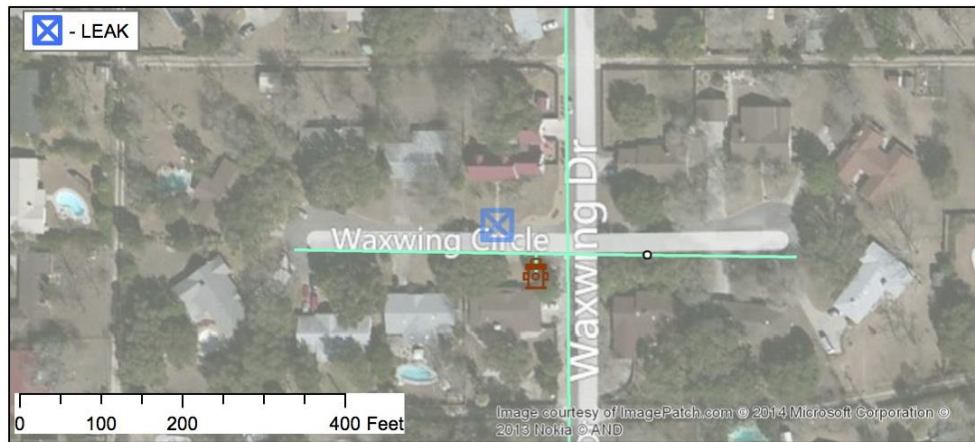
Date: 4/24/2014
Grid Map: 0
Address: 513
Street: WAXWING CIRCLE
Access: PUBLIC
Leak Class: 1
Est. Water Loss: GPM 1
Leak on asset (type): METER LEAK - CITY
Surface: GRASS
Pipe Material: UNKNOWN
Leak Technician: Kris Henley
Cross Street: WAXWING DRIVE
Main Size (Inches) UNKNOWN
Detection Method
Sonic: YES
Visible Leak: YES
Other:

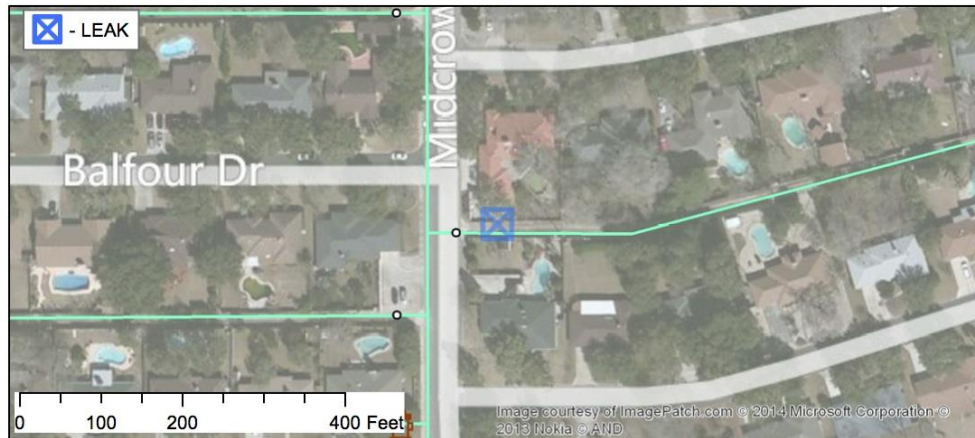
Leak Report Windcrest TX 2014

Address: 502

Street: BALFOUR DRIVE

Leak Class: 1

Est. Water Loss: GPM 1

METER LEAK - CITY

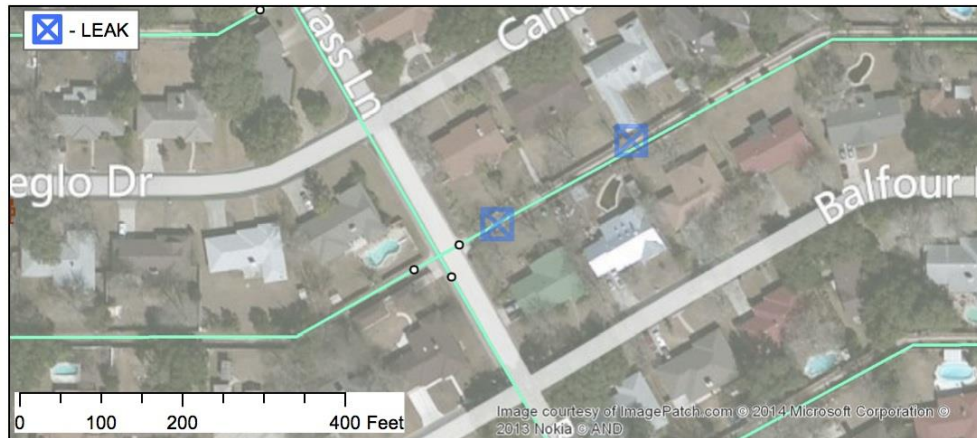
Leak Report Windcrest TX 2014

Address: 602

Street: CANDLEWOOD

Leak Class: 1

Est. Water Loss: GPM 1

METER LEAK - CITY

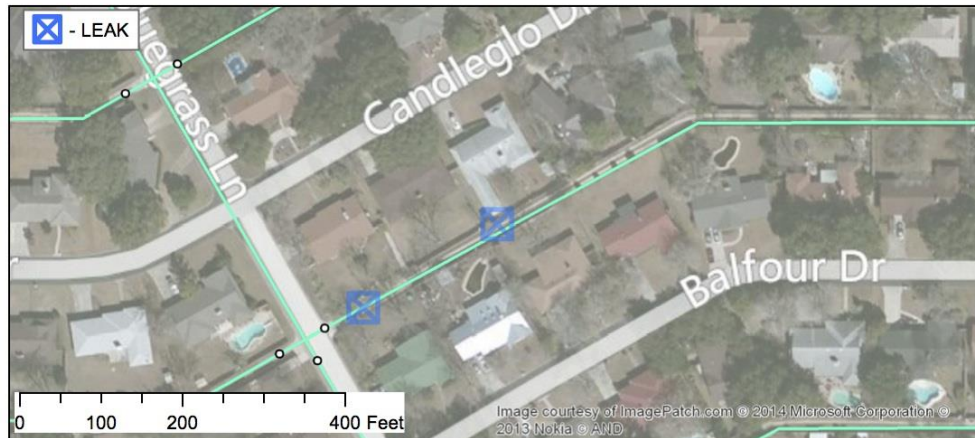
Leak Report Windcrest TX 2014

Address: 610

Street: CANDLEWOOD

Leak Class: 1

Est. Water Loss: GPM 1

METER LEAK - CITY

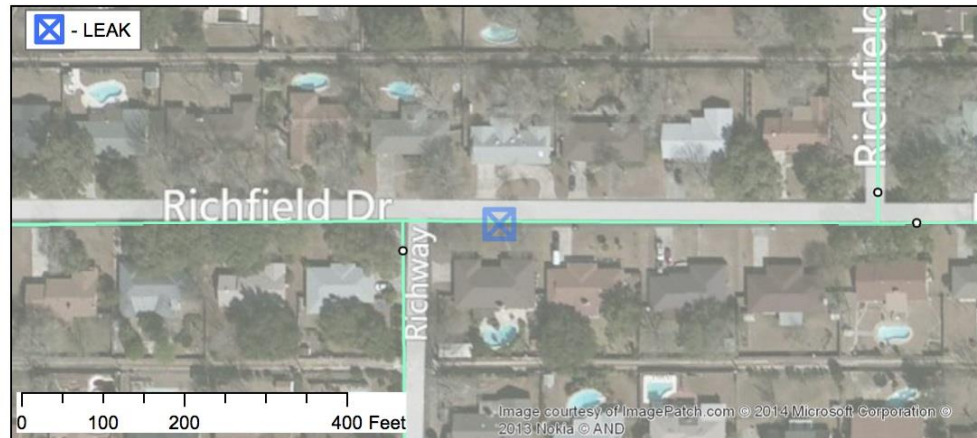
Leak Report Windcrest TX 2014

Address: 634

Street: RICHFIELD DRIVE

Leak Class: 1

Est. Water Loss: GPM 1

METER LEAK - CITY
