City of Windcrest

Leak Detection Pilot

Leak Report Windcrest TX 2014

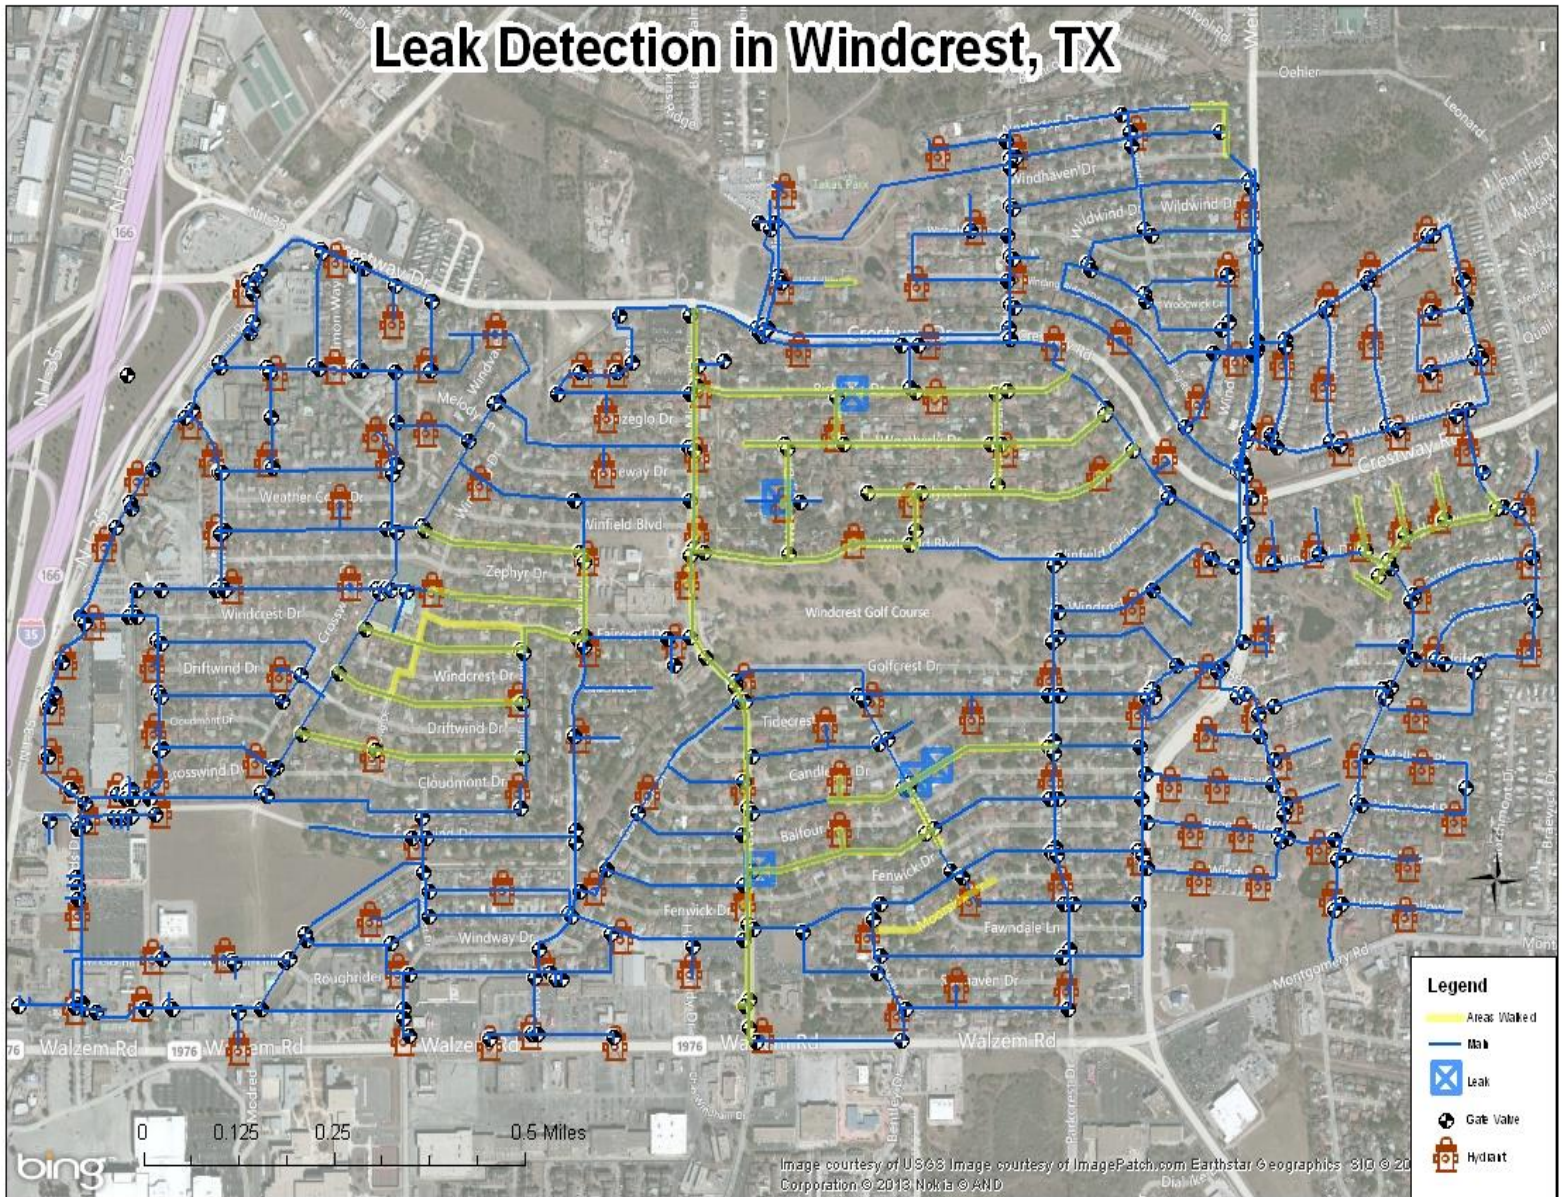
Leak Detection in Windcrest, TX

- The Wachs Water Services Leak Detection Survey conducted on the City of Wincrest distribution system, resulted in the location of approximately 7,200 gallons of water per day in leakage. Also during the survey, it became aware that the city still has many outdated meters that may be inaccurate and not registering low flowing water. The city may also want to insure all meters are being read accurately. Master meters on wells need to be tested for accuracy and all check valves need to be checked to insure proper operation to prevent double counting of water, since storage tanks look to be bottom fed. It is recommended that a proactive leak detection survey needs to be conducted on a yearly basis to help reduce underground water loss and improve the infrastructure of the water distribution system.

- During the survey Wachs Water Services came across three valve casings that were ran over by the milling machine, completely destroying the casing and burying the op nuts. In case of an emergency these valves would have been rendered inaccessible. It is recommended that the City of Windcrest inspect all water distribution valves in construction areas to insure access and operability.
